**DEFINITION OF REVERSE OSMOSIS PUMP REQUIREMENTS  
FOR SPACE VEHICLE APPLICATION**

**Final Report**

**MDC G4744**

**PREPARED FOR THE OFFICE OF SALINE WATER, U.S. DEPARTMENT OF THE INTERIOR,  
UNDER CONTRACT OSW 14-30-3082**

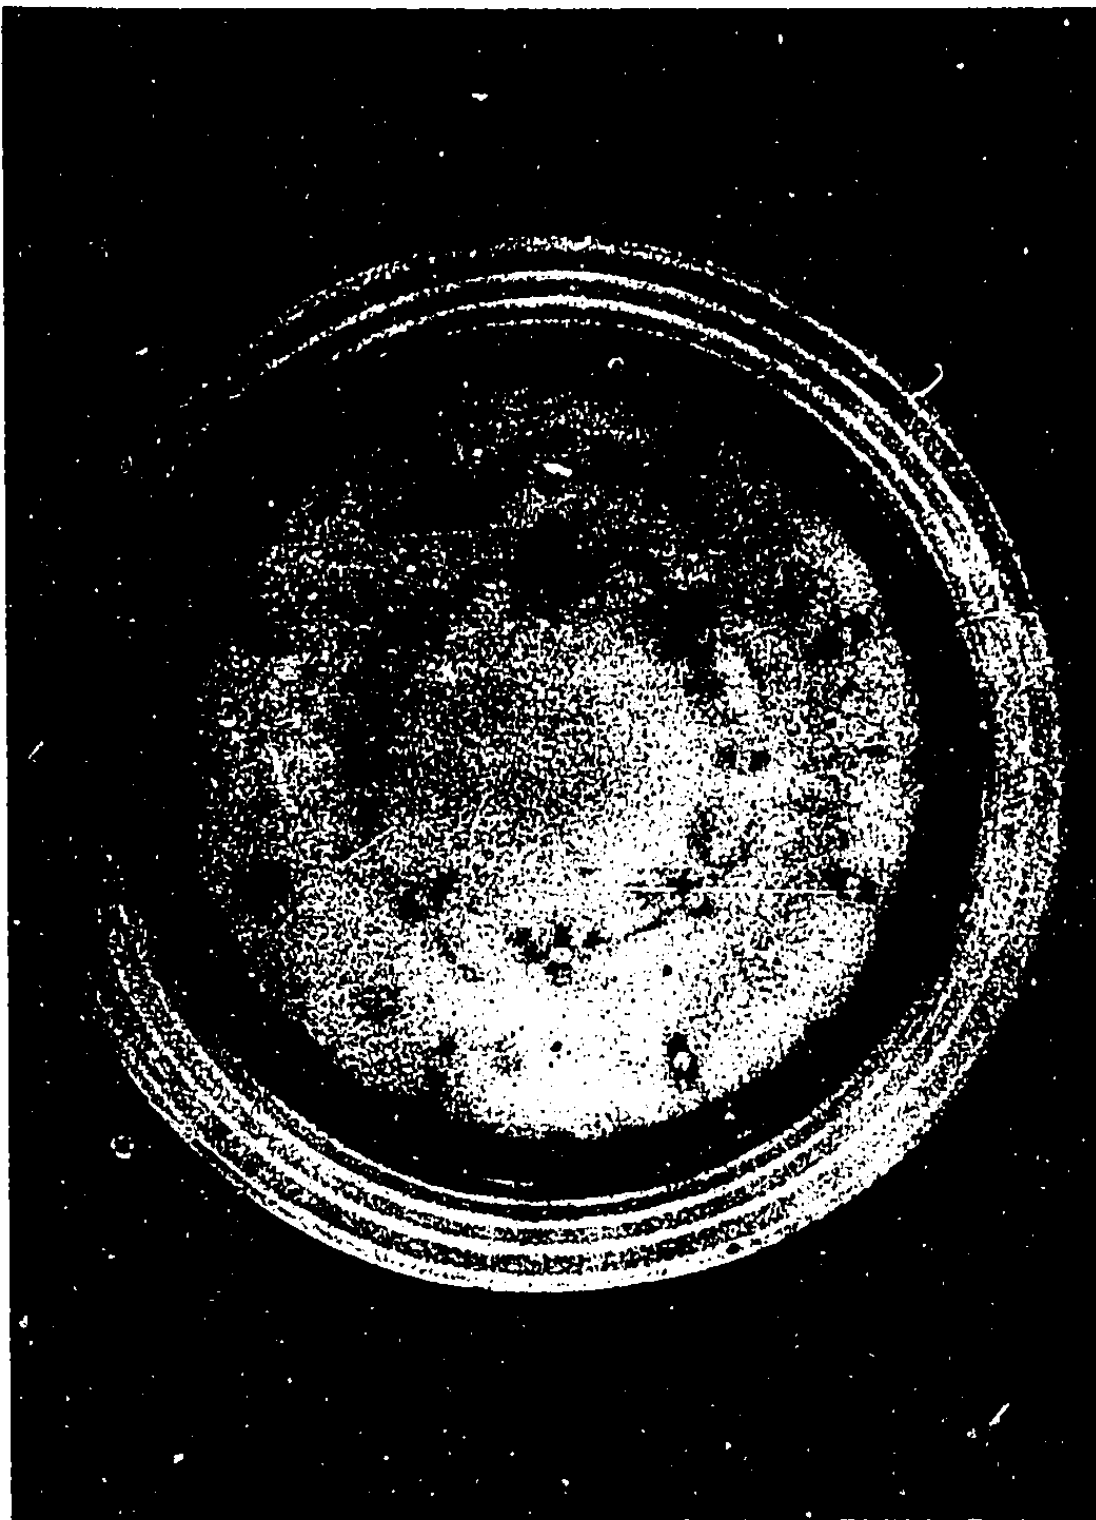
Figure 4-14. Oil Side of Milton Roy Pump (P1) Diaphragm After Test
